Energy efficient residential buildings in Belarus

Analysis and recommendation

Baltic Environmental Forum, Hamburg, 2016

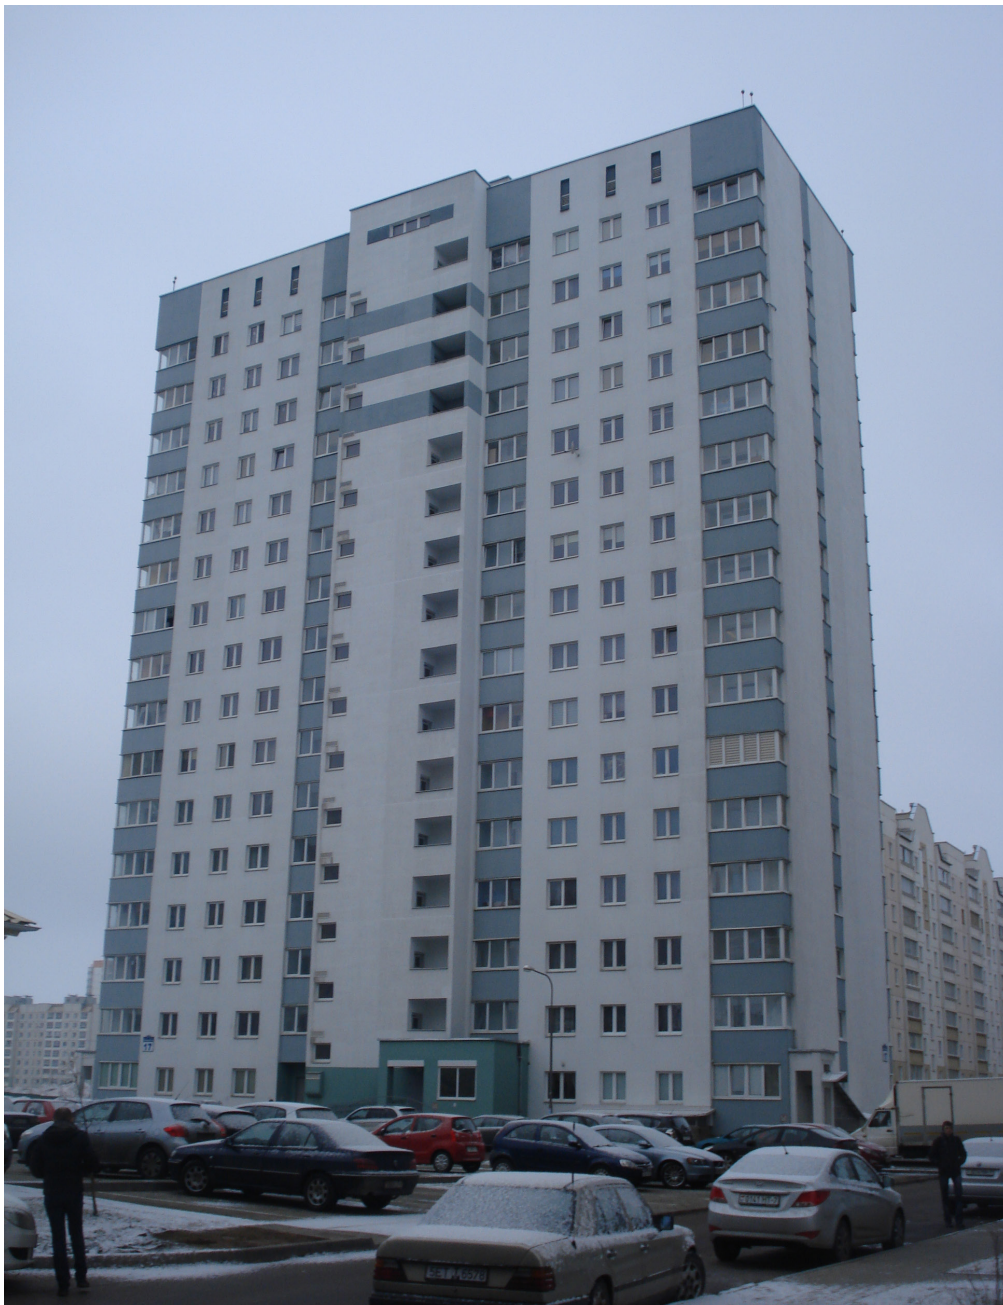
Kazimirovskaya 17. Picture: R. Scharnowski

The inspection of the building found a few critical points on the outside of the building, in particular not properly installed windows, missing or damaged sealing and sealing foam which is not properly covered. Flats are equipped with a mechanical ventilation system which includes a heat exchanger in the 16th floor. Supply air is provided in the living rooms while the exhaust air vents are located in kitchens and bathrooms. 64% of the interviewed residents do not use other ventilation systems than the one installed, other use fans or classical ventilation through windows and doors to improve air ventilation and circulation. Radiators are equipped with thermostat valves so that the indoor temperature can be regulated by the flat owners. Thermographic measurements at walls and windows indicate big temperature differences between surface and indoor air. On average, this difference was higher at windows and in some cases the window frame temperature is be-

low the dew point temperature, which indicates that the quality of window installation is not satisfactory. This varies from room to room, however, so that systematic errors can be excluded, such as a poor quality of windows. The result is supported by the survey results where 24% of the respondents claim that the windows are not installed properly; approx. 18% say that they have defects in their window sills and 9% say that they have mould near the windows.

Careful repair of gaps between window frame and wall, if possible new airtight sealing from inside and outside. Installation of insulation between heated and unheated common spaces according to fire protection requirements.

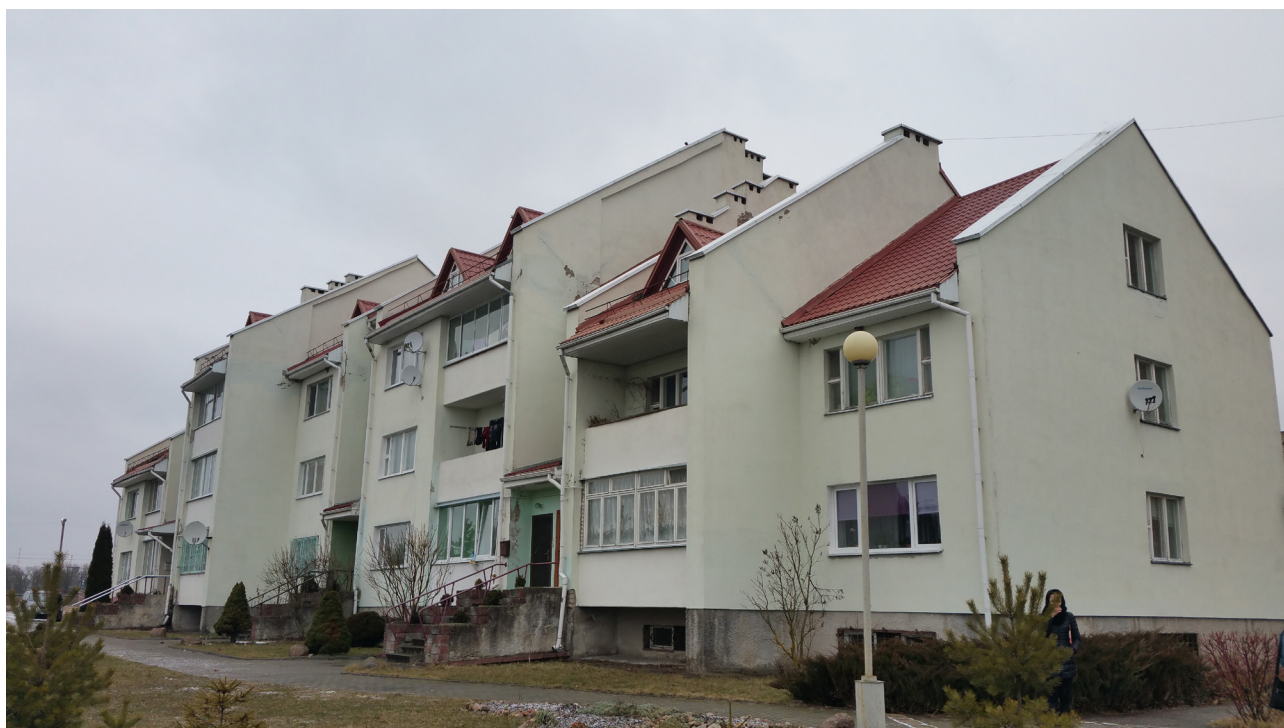
1st Khasanovskaya St. 62, Lida. Picture: R. Scharnowski

During the inspection of the building at place, humidity damages, cracks, and damages at plaster were detected on the outside of the building. Especially, the complex profile of the roof edge generated problems with the water drainage. Despite the relative young age of the building, the flats offer no regulation by valves at the thermostats. The rooms are equipped with old fashioned types of heaters. However, the pipes are well insulated in non-heated areas of the building.

The metering results on the walls and ceilings that were undertaken during the site visit, confirmed the existence of thermal bridges. Especially at the windows, the temperature difference between surface and room temperature is significant.

In mid-term, it is recommended to repair the rain drainage system to avoid further damage. The insulation of the ceiling to the unheated attic storey should be considered. Last but not least, thermostat valves should be installed at all radiators inside the flats.

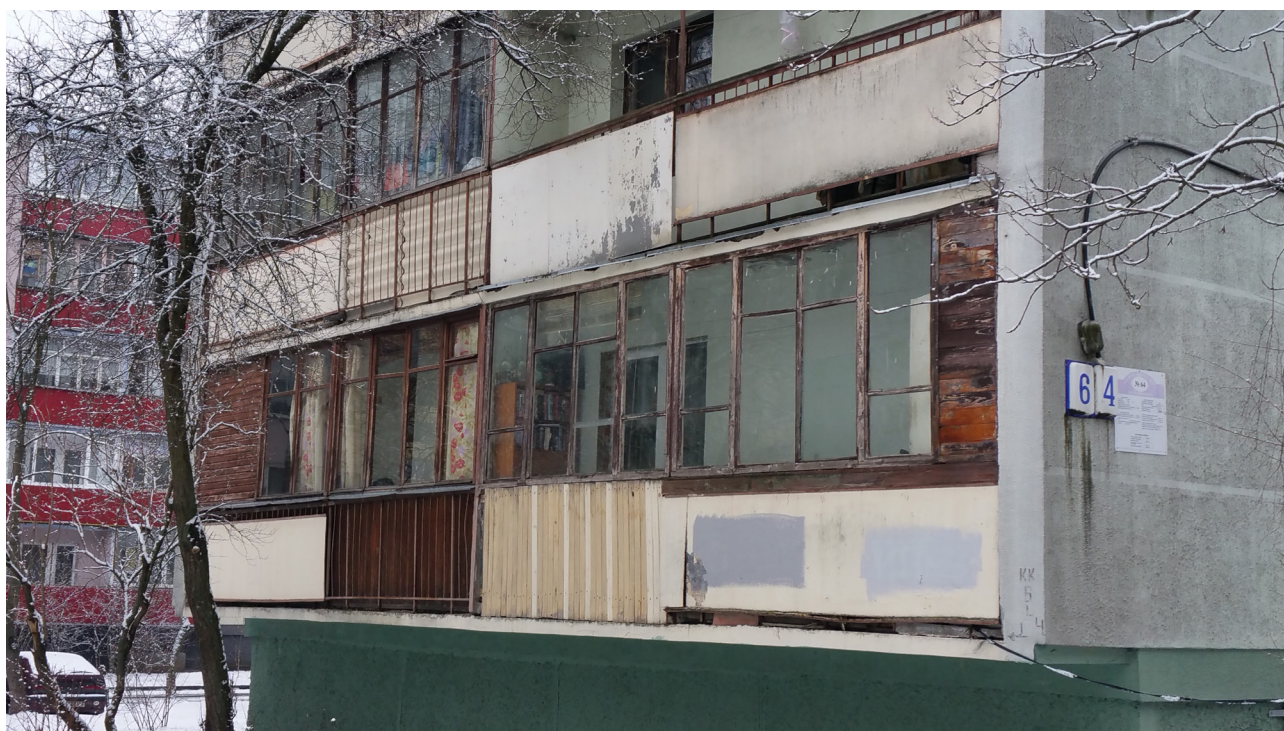
Kalinovskogo St. 64. Picture: R. Scharnowski

In general, the building is well-maintained, especially the roof covering. The inspection of the building showed that only a small number of flat owners actually did replace their windows before the building was insulated. Installation of new windows after refurbishment would cause problems with the installed thermal insulation system. Furthermore, the balconies were not upgraded or even altered. The initial single pipe wall heating system was not replaced during the refurbishment. Thus, it is still not possible to regulate the temperature inside the flats. For most flats, the insulation of the outer wall remains the only measure during the refurbishment process which has an influence on the heat consumption. The flats that were visited

were located in the middle of the single pipe-circulation line. In those flats, the windows were kept open to keep the temperature around 19°C. However, the low surface temperatures of the old-fashioned window frames leads to the fact that in some cases, even the dew point was met. This problem does not occur on the walls thanks to the wall heating system.

As the former single pipe wall heating system was not changed, it is still impossible to regulate the temperature inside the flats. Consequently, the energy consumption is not influenced by the inhabitants' behaviour. Any exchange of the old windows (to avoid energy losses and dew points) should only be done taking into account the requirements of the insulation. A more comprehensive refurbishment of the building would require the exchange of the heating system of the whole building, the installation of heaters and thermostat valves. This would, however, demand a complex solution as the current heating system cannot be exchanged easily and would probably require the installation of a completely new system additionally while shutting down the existing heating system.

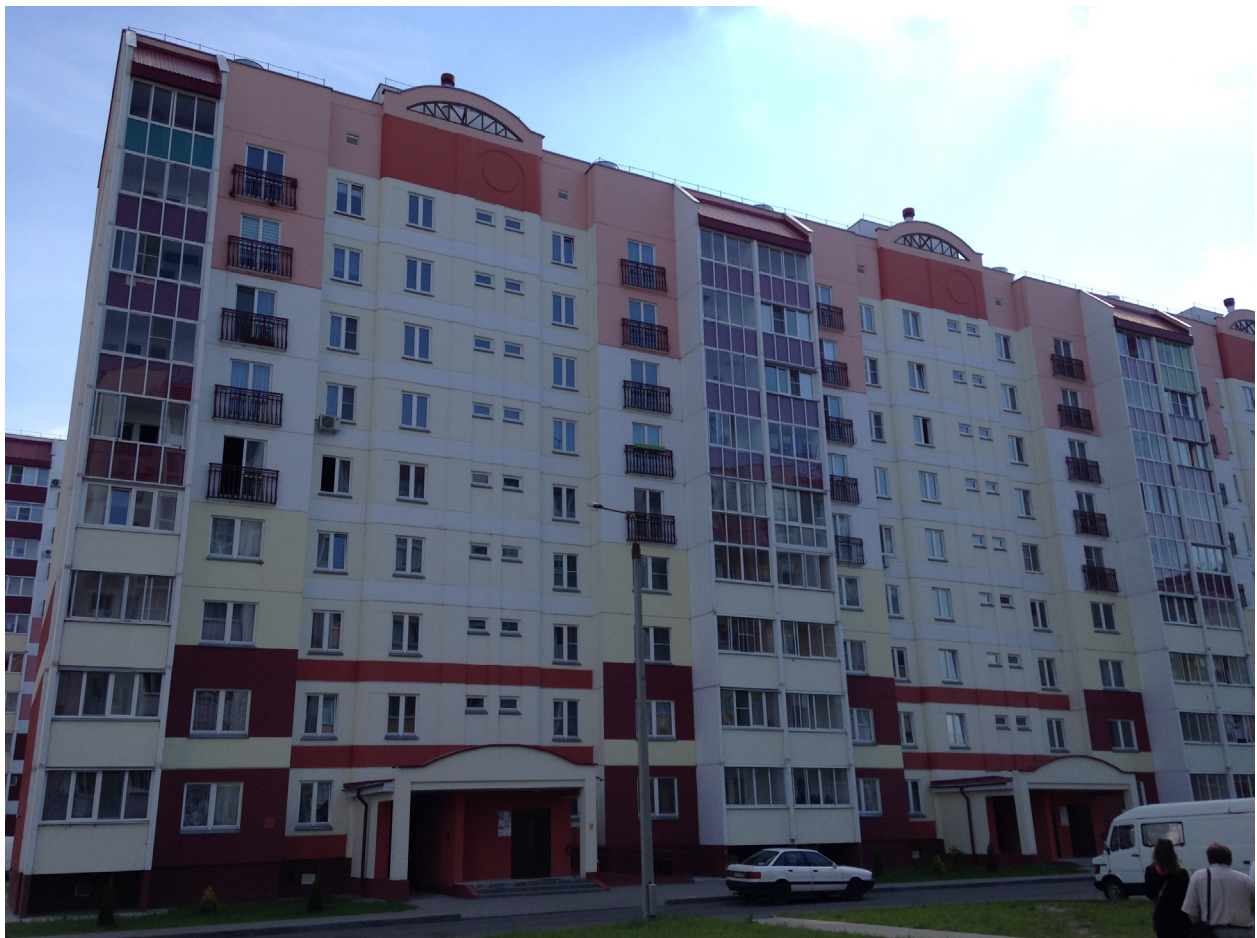
Borodina St. 18, Gomel'. Picture: R. Scharnowski

The inspection of the building led to few findings on the outside of the building. Apart from some not properly installed window sills, no critical points were identified. Inspecting some apartments from the inside showed that some radiators cannot be regulated by valves and that heater models are rather old-fashioned. The flats are not equipped with a ventilation system, despite the fact that this is the youngest building analysed in the project. Thermographic measurements at windows reveal significant thermal bridges. A significant difference of more than 6,5°C between the metered surface and indoor temperature indicates the

critical condition in which thermal bridges are forming. These seems caused by a deficient installation of the windows whereby no systematic error could be detected.

The exchange of old fashioned valves according the balance of the whole heating system is needed eventually. In some cases the reorganization of covered heaters to improve their efficiency should. Careful repair of gaps between window frame and wall, if possible new airtight sealing from inside and outside. A repair of damaged plaster is recommended to avoid more damages.

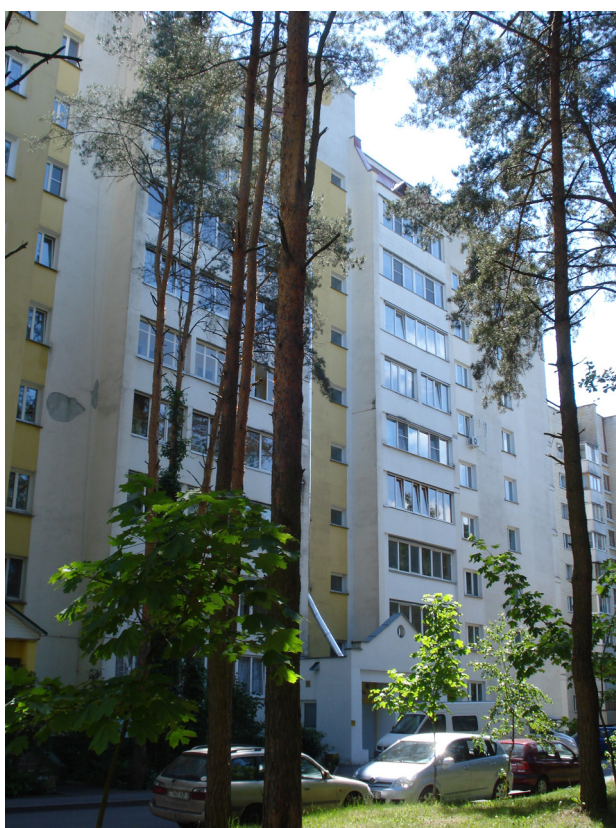
Solnechniy, Gomel'.
Picture: R. Scharnowski

The outside of the building shows some damage on plaster and walls. This was also confirmed in the residents' survey, where 24% of the respondents confirm to have cracks in the walls. Furthermore, some parts of the plaster were humid on the outside and some of the windows were not properly sealed or installed. Regarding the interior of the building, the heaters inside the flats are equipped with thermostatic valves, so that the temperature can be regulated inside the flats. However, the windows emerge as a problem: a significant difference (6,5°C) between the metered surface and indoor temperature indicate the critical

conditions in which thermal bridges form. This measurement is also supported by the survey among residents in which 22% of the respondents confirm the formation of mould near the windows. This is caused by a deficient installation of the windows: 16% of the interviewed residents say that their windows are not installed properly and 10% noticed defects at the window sills. However, similar to the building in Borodina St, the quality of window installation differs from room to room, there are no systematic construction mistakes.

The repair of seal at the window wing, a careful repair of gaps between the window frame and wall, and if possible new airtight sealing from inside and outside would be necessary.
